## **An Investigation of Concrete Deterioration at South Florida Water Management District Structure S65E**

February 2014

Final report

Prepared for US Army Engineer District, Jacksonville  
701 San Marco Blvd  
Jacksonville, FL 32207

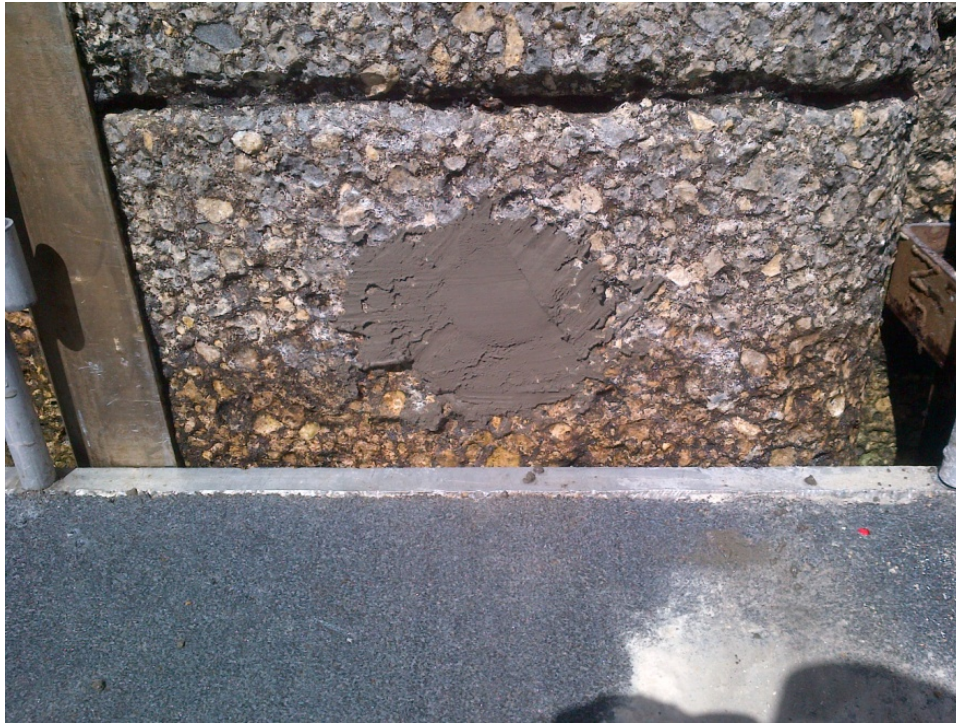
Concrete deterioration reported to ERDC by the Jacksonville District personnel focused on significant deterioration of the surface of the concrete. A photograph of typical concrete deterioration observed in an area where concrete cores were extracted is shown in Figure 2.

Figure 2. Typical concrete deterioration at location where concrete core was extracted.

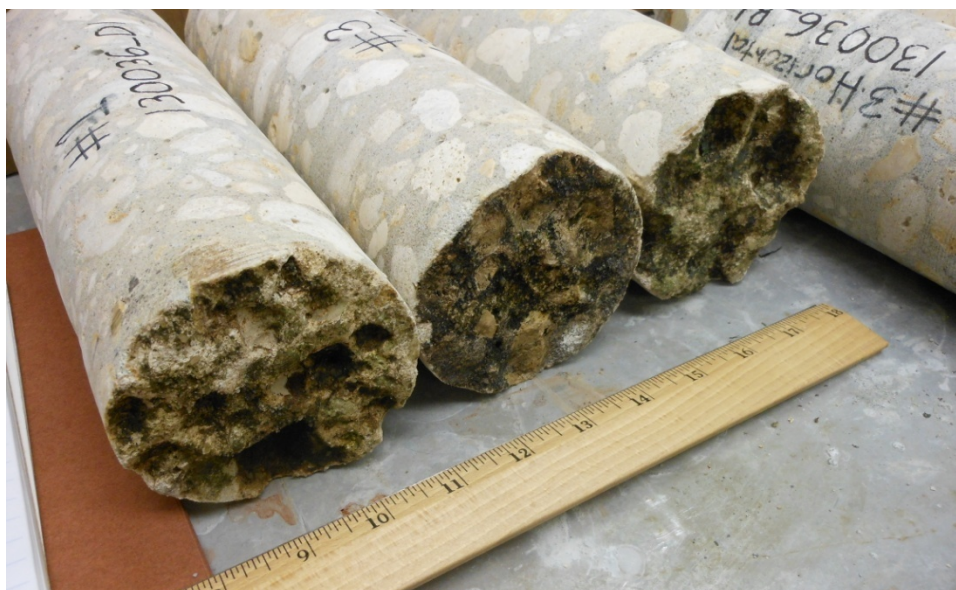
In coordination with Jacksonville District personnel, concrete core samples were extracted and shipped to ERDC along with water samples collected at the site. Concrete was cored from non-deteriorated, deteriorated, and repaired areas of the structure. Seven cores were received: three from deteriorated areas, two from repaired areas, and two from non-deteriorated areas. A summary of cores received is provided in Table 1. Four of the seven cores received were used for analysis. Figure 3 shows an image of surface deterioration observed in as-received cores from deteriorated areas of S65E.

Figure 3. As-received concrete cores from deteriorated areas of S65E.

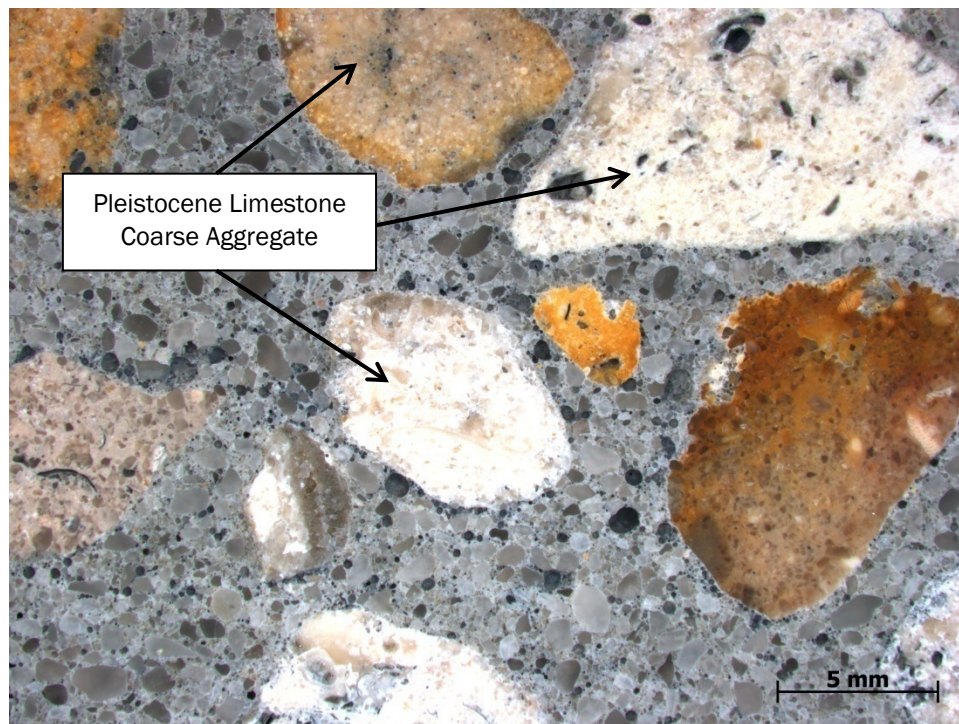
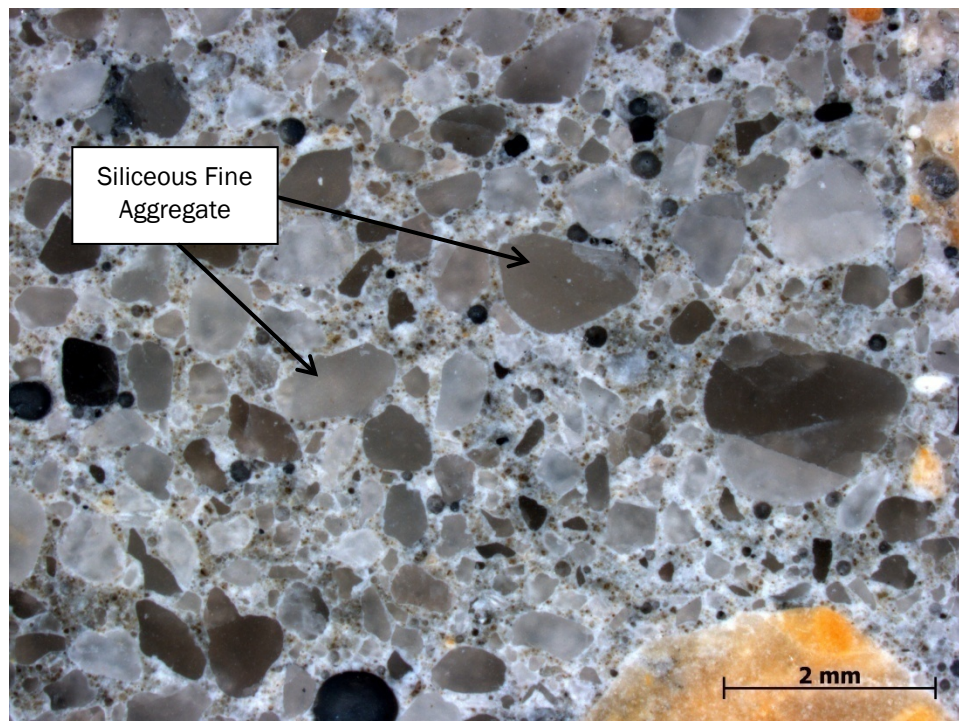
Prior to examination of non-deteriorated, repaired, and deteriorated concrete from near the exposed surface, an examination of the bulk concrete was made to assess concrete quality and identify coarse and fine aggregates. Typical photomicrographs of the bulk concrete are shown in Figure 4. The concrete appeared to be competent and of high quality. Coarse aggregates were primarily a Pleistocene limestone commonly used in concrete in Florida. Fine aggregates were primarily siliceous. No evidence of deterioration was observed in the bulk concrete that was isolated from any surface deterioration present in the as-received concrete cores.

Figure 4. Photomicrographs of typical bulk concrete showing distribution in air voids, coarse aggregates, fine aggregates, and paste.

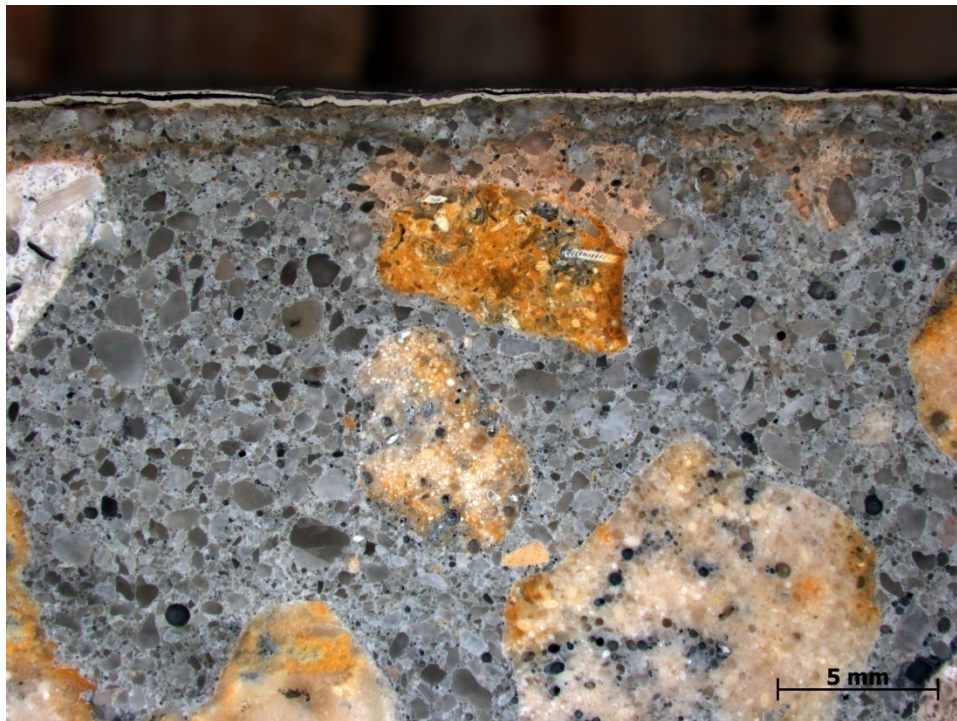
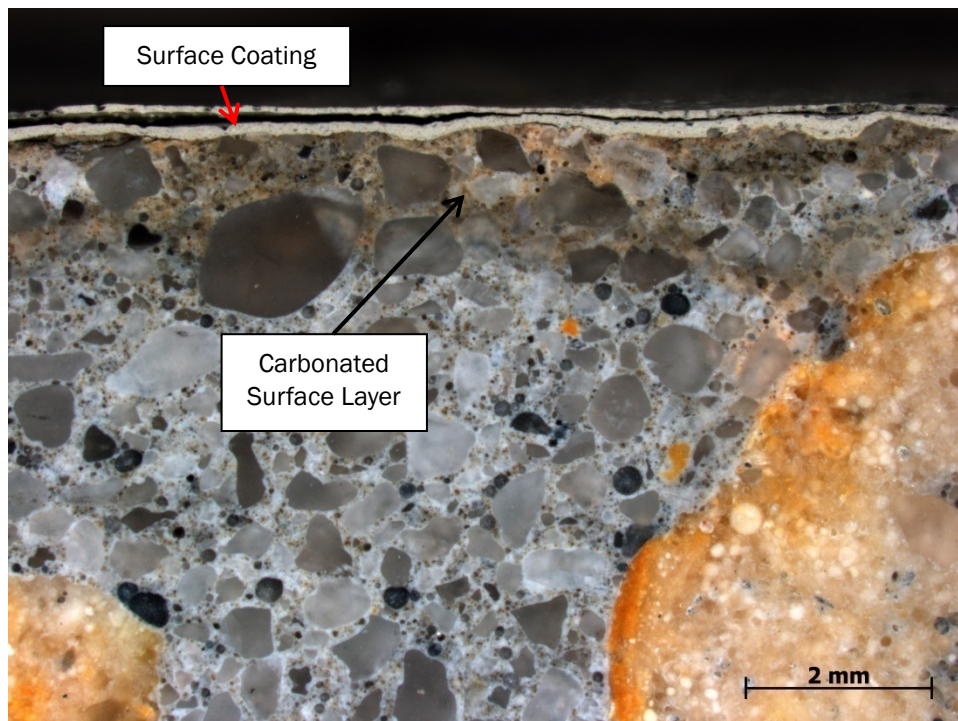
The condition of non-deteriorated concrete surfaces of as-received core 130036\_N1 was examined using stereomicroscopy. Figure 5 shows typical photomicrographs obtained from cross sections of the non-deteriorated surface concrete. Similar to the bulk concrete, the coarse aggregate was a Pleistocene limestone, and the fine aggregate was siliceous. The non-deteriorated surface was extremely planar and well finished. A surface paint/coating layer was also evident in the as-received cores. A layer of discoloration was observed to penetrate to a depth of approximately 1.5 to 2 mm from the surface. The discoloration is likely associated with carbonation of the surface concrete by slow reaction of  $\text{Ca}(\text{OH})_2$  present in the concrete with atmospheric  $\text{CO}_2$ . The presence of carbonation was confirmed with the use of the phenolphthalein pH indicator solution (see Figure 6). Other than the minimal carbonation observed, no other evidence of distress was observed in concrete from non-deteriorated areas of the structure.

Figure 5. Photomicrographs of typical concrete at surface of non-deteriorated areas of S65E.

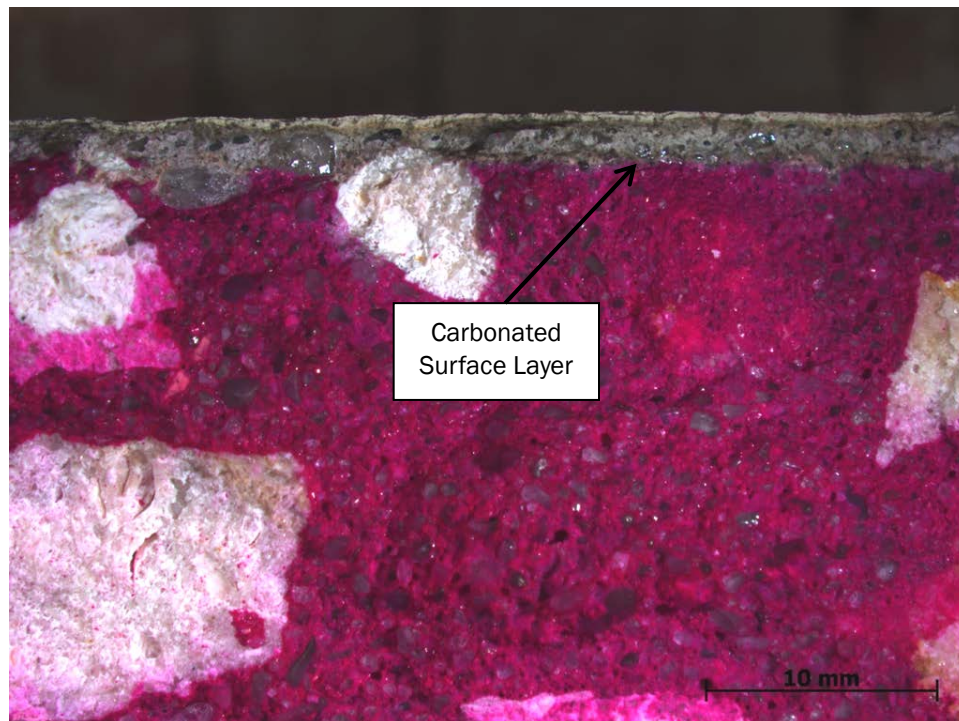
Figure 6. Surface of non-deteriorated concrete showing depth of carbonation using phenolphthalein pH indicator solution.

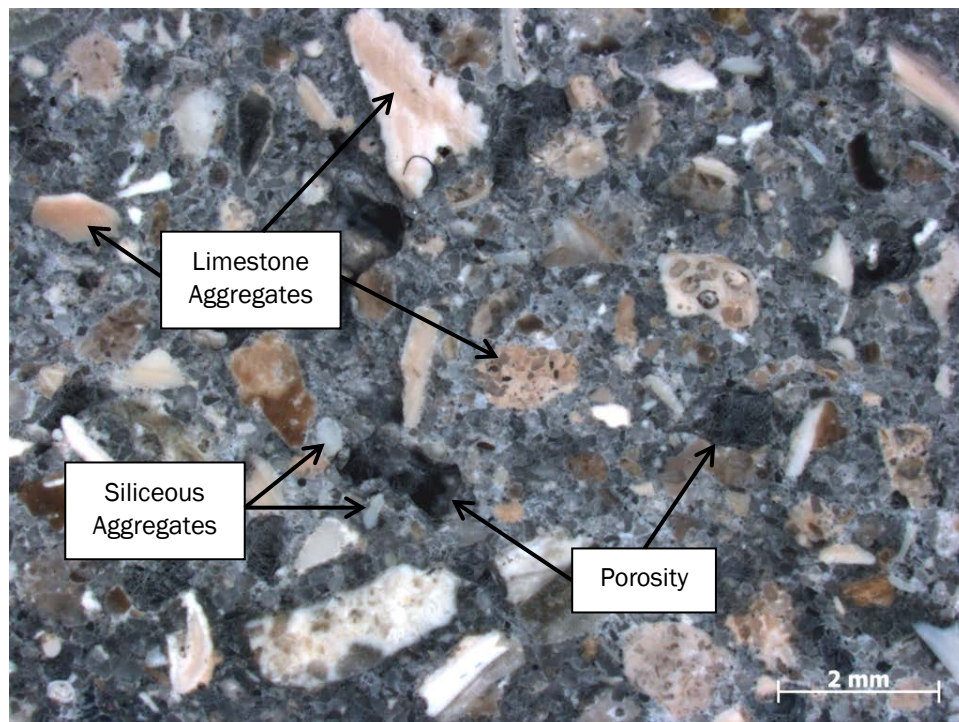
Concrete that was previously repaired due to deterioration of the original concrete at S65E was also examined. Figure 7 shows the typical microstructure observed in the shotcrete repair material. The shotcrete material contained a mixture of limestone and siliceous aggregates. The shotcrete was also found to be highly porous. The surface of the as-received repaired concrete had higher surface roughness than the original concrete examined from non-deteriorated areas of the structure (see Figure 8 of shotcrete surface vs. Figure 5 of original concrete surface). It is unclear whether this surface roughness is related to subsequent deterioration following application of the repair shotcrete or whether the initial finish of the shotcrete repair exhibited increased roughness.

Figure 7. Typical microstructure of shotcrete used for repair, which consisted of limestone and siliceous aggregates and significant porosity.

cementitious materials) and improve acid resistance (e.g., use of silica fume) would likely improve the durability of the repair material. The use of a high quality repair material that is durable will also serve to better protect the underlying concrete from subsequent deterioration.

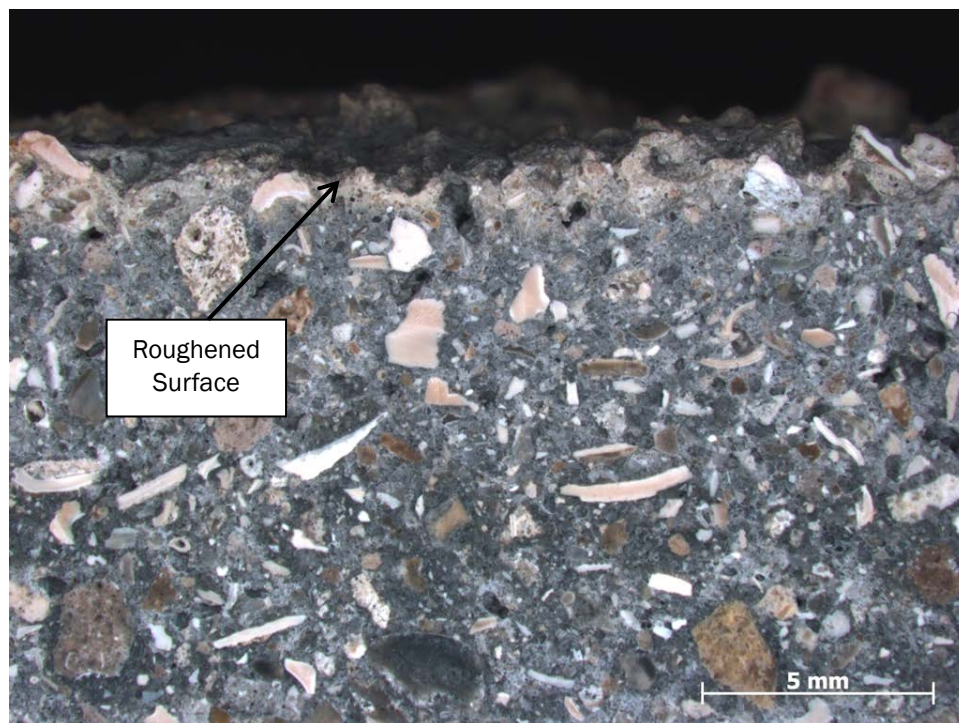
Figure 8. Photomicrograph of surface of shotcrete repair material showing high roughness.

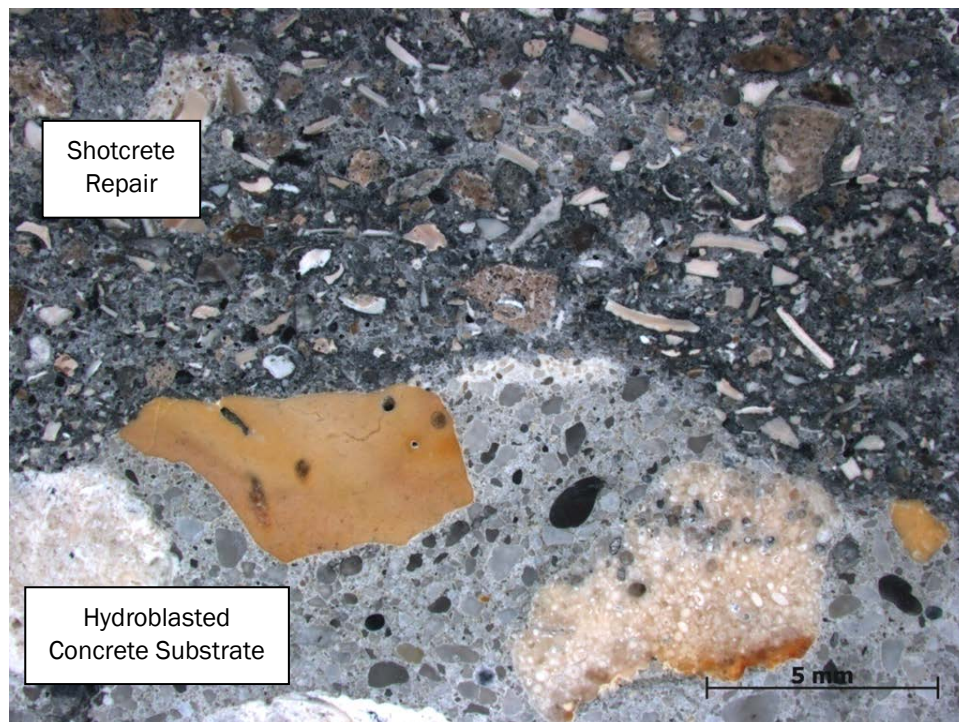
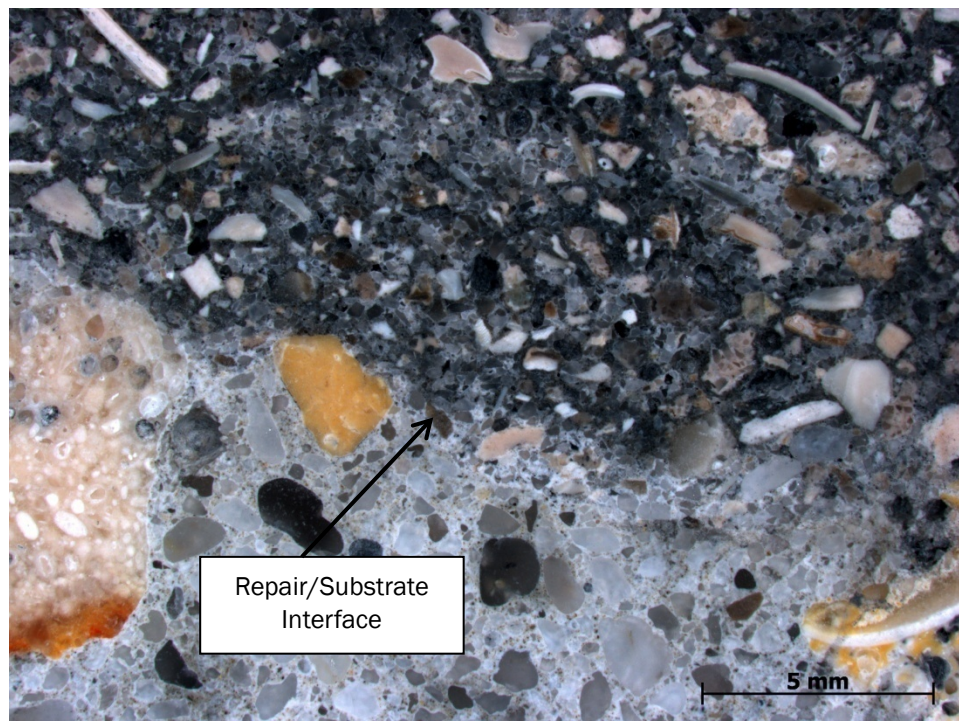
The interface between the shotcrete repair material and the original concrete substrate, which had damaged concrete removed by hydroblasting, was also examined. Figure 9 shows examples of the typical interface observed between original concrete and the shotcrete repair material. Overall, the interface between the shotcrete and the original concrete substrate appeared to be well bonded. However, sparse porosity and delaminations were observed at the interface, which corroborates the findings presented in a report provided to ERDC by Jacksonville District personnel.

Figure 9. Photomicrographs of typical interface between the shotcrete repair material and the original concrete substrate.

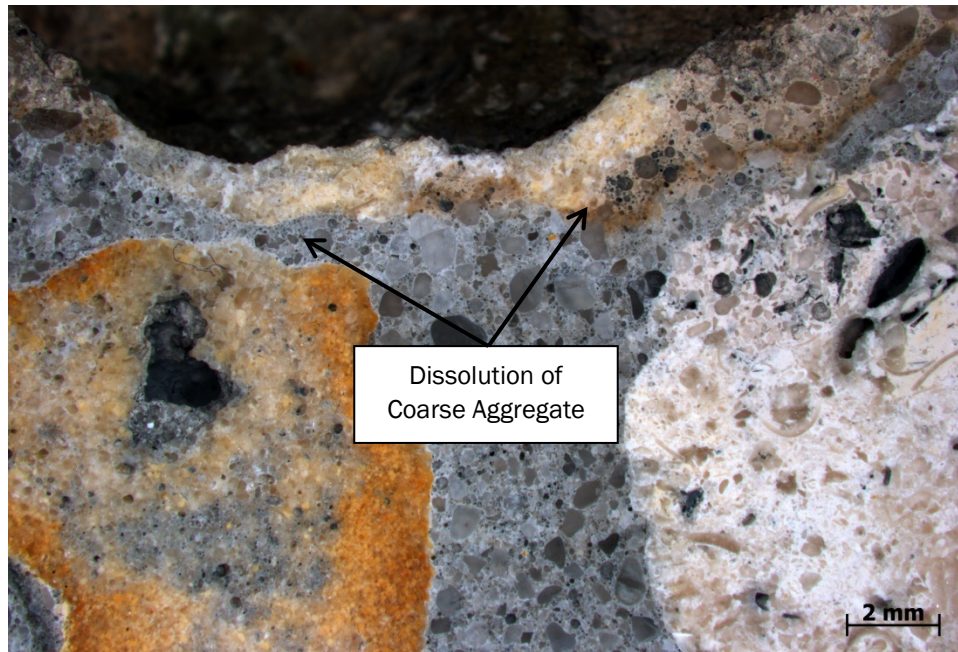
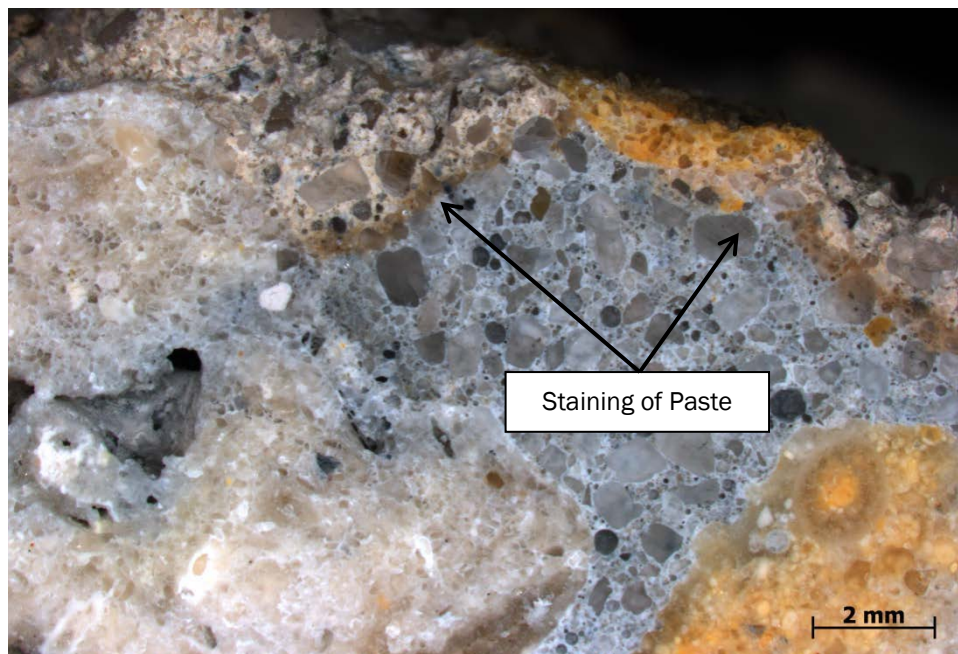
The primary focus of the petrographic analyses conducted was to investigate distress on cores from deteriorated areas of the structure. Concrete was examined from two deteriorated locations in the structure: (1) concrete from high flow rate areas in dam piers and (2) concrete from low flow rate areas in the lock chamber. Figures 10 and 11 show typical surface distress observed in deteriorated concrete from the dam and lock chamber, respectively.

Deterioration in concrete from the dam had reached depths approaching 25 mm, which was approximately half of the cover depth observed over embedded reinforcing steel. Concrete from the lock chamber only exhibited deterioration to a depth of approximately 10 mm. It is hypothesized that the increased depth of deterioration in concrete from the dam may be related to the increased flow rates in the spillway when compared with flow velocities to which concrete surfaces in the lock chamber are exposed.

Figure 10. Photomicrographs of typical deterioration in concrete from dam piers.

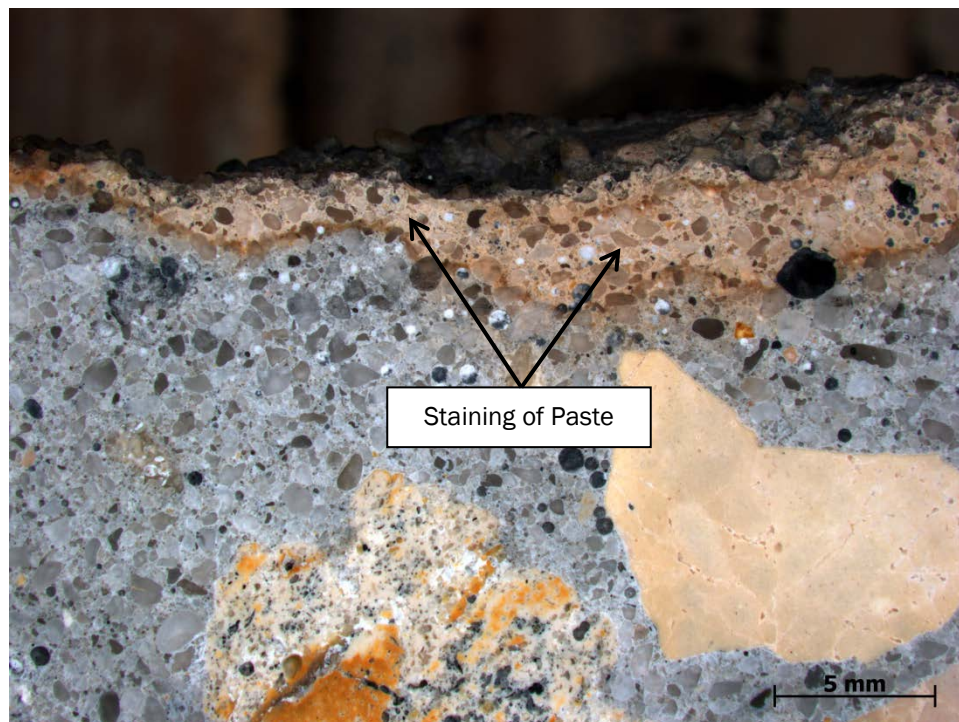
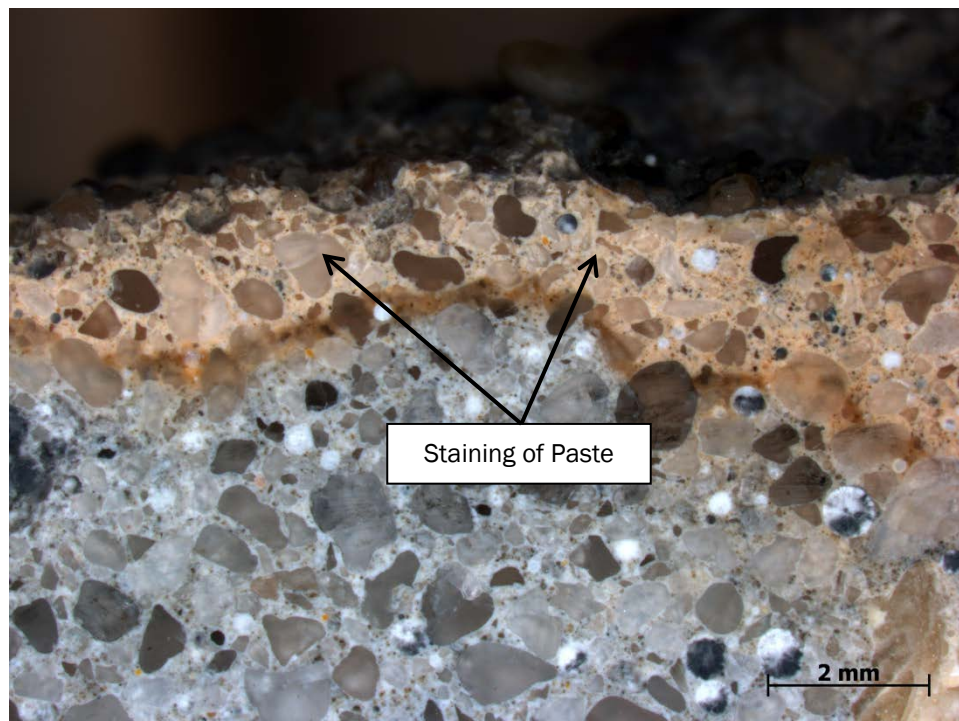
Figure 11. Photomicrographs of typical deterioration observed in concrete from lock chamber.

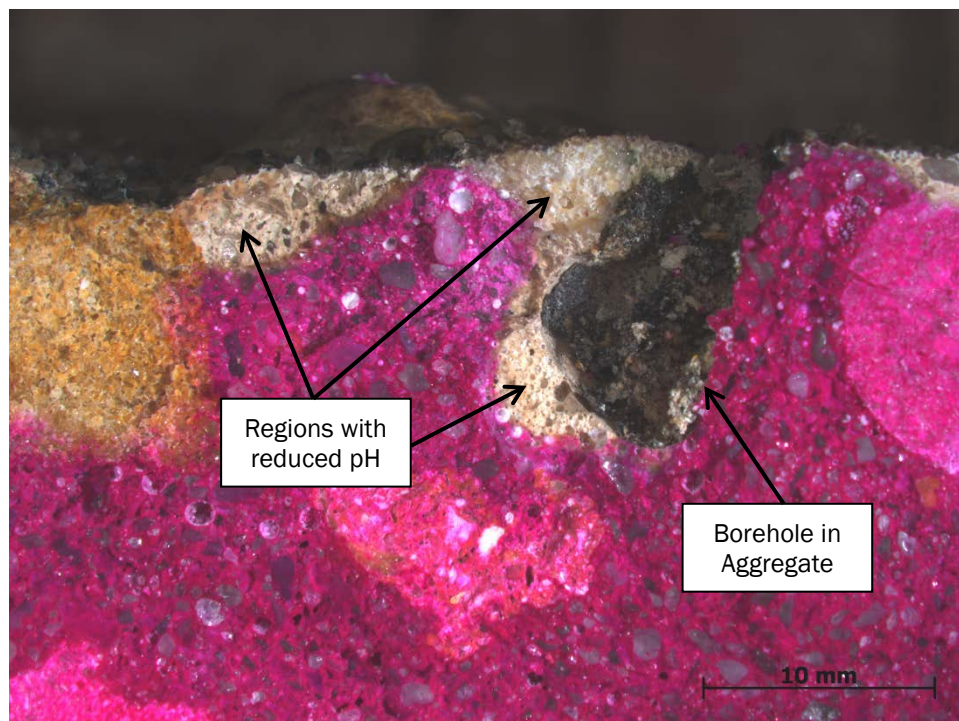
In concrete from the dam and the lock, a surface layer of discolored concrete that is likely associated with acidification/carbonation (see Figure 12) or other forms of distress causing the surface deterioration were observed. Reduction in pH also appeared to be correlated with staining and the location of significant surface damage of the concrete. A borehole was also observed in one of the coarse aggregates, which was associated with the acidification front (see Figure 12). The deterioration was observed to focus primarily on the Pleistocene limestone aggregates and to a lesser extent on the hydrated cement paste itself. High magnification imaging of the surface concrete showed that the siliceous fine aggregates were largely unaffected by the surface deterioration (see Figures 13 and 14).

Based on water quality measurements, a lack of softening or spalling of the near surface concrete and the propensity of deterioration to focus on the Pleistocene limestone coarse aggregates and paste fraction of the concrete, it is unlikely that the distress results from sulfate attack or acid attack. No rust staining or microcracking was observed, which would be evidence of corrosion of the embedded reinforcing steel and would corroborate the low  $\text{Cl}^-$  concentrations measured in the water at S65E. A possible mechanism responsible for the observed distress is some form of biodeterioration, which has been previously observed in coastal and inland concrete structures. Biodeterioration may result in local acidification of the surface concrete, which would result in dissolution of limestone aggregates and decalcification of the paste but would have limited effect on siliceous fine aggregates. The aggregates and paste may also function as a direct food source for the biota with no acidification present. A second mechanism could be inorganic dissolution of limestone aggregate in contact with surface water having low carbonate alkalinity, as is typical in the Kissimmee River. This mechanism could explain limestone aggregate dissolution under neutral pH conditions.

Figure 12. Acidification/carbonation depth of surface concrete evidenced by pH indicator. A borehole likely caused by biodeterioration was also observed.

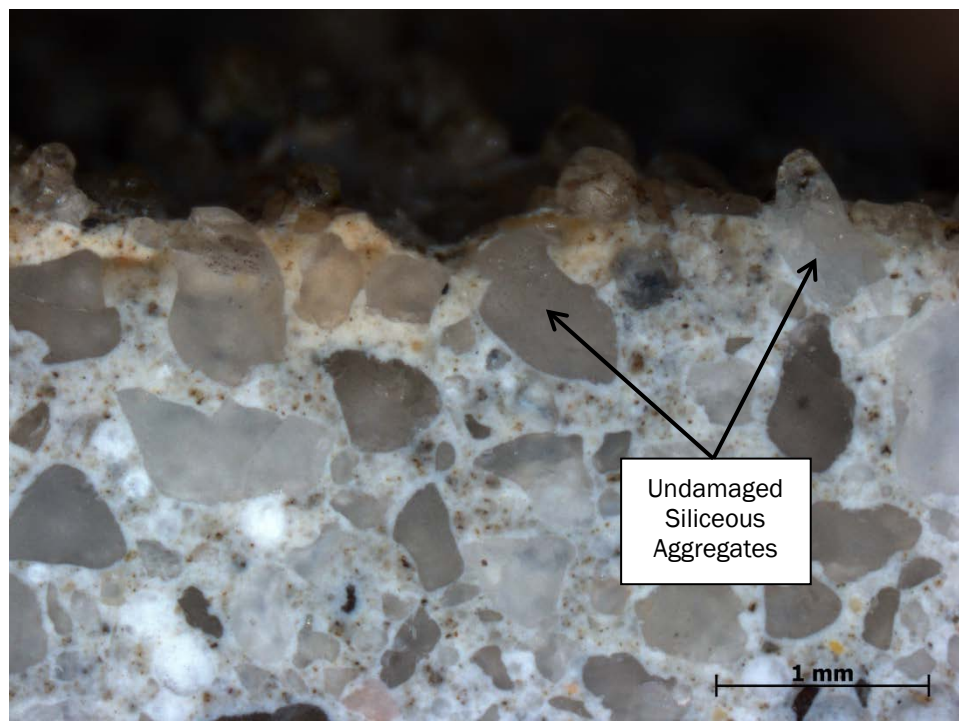
Figure 13. Photomicrograph of polished cross section of exposed concrete showing limited deterioration of siliceous fine aggregates when compared with limestone coarse aggregates and paste in exposed areas.

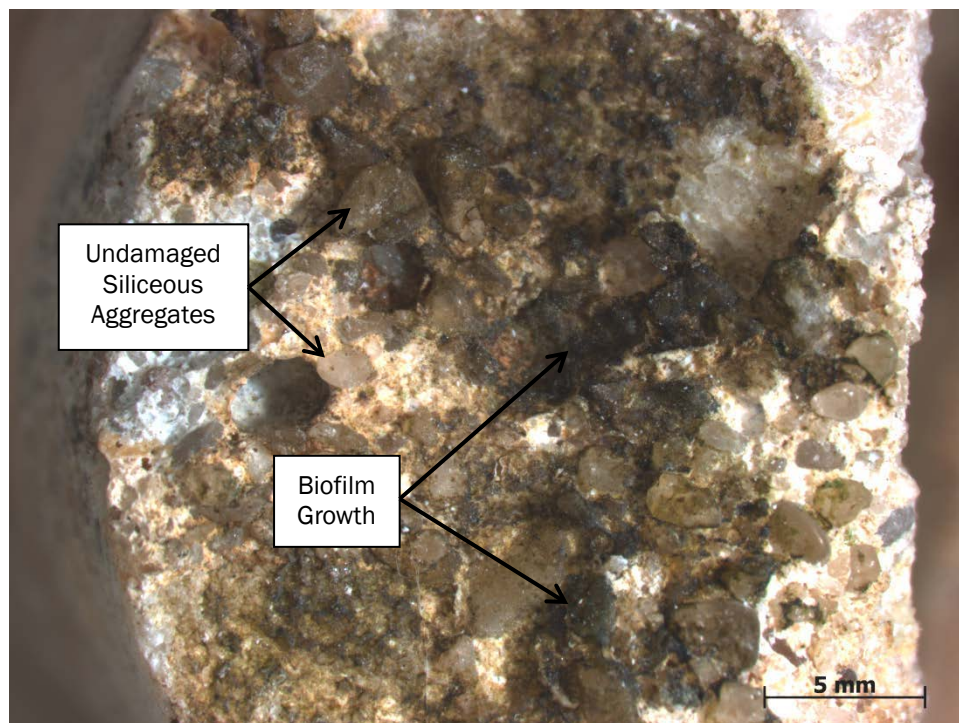
Figure 14. Photomicrograph of exposed surface of concrete showing biofilm growth and lack of damage to siliceous fine aggregates that remain exposed.

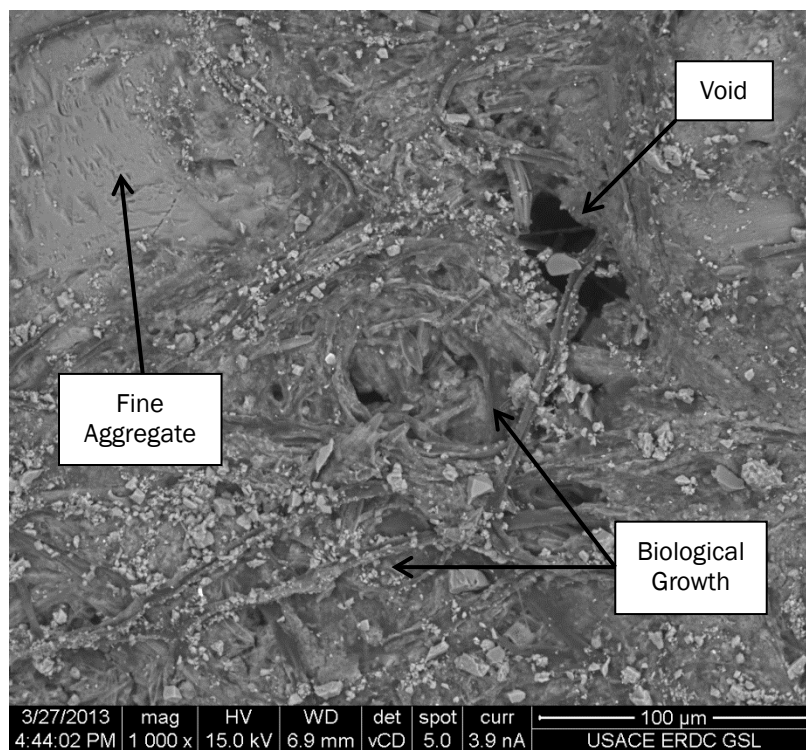
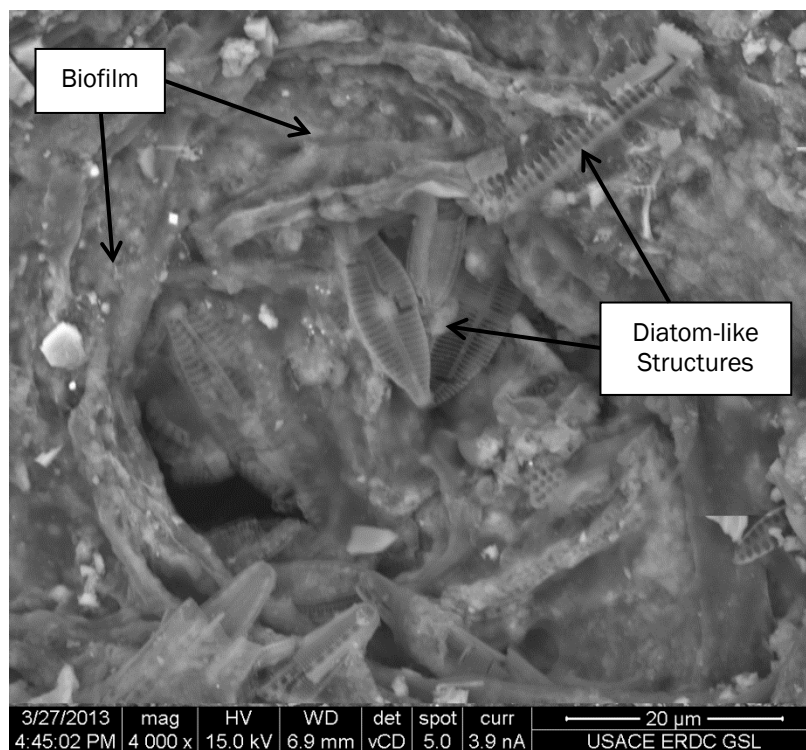
High-resolution imaging of deterioration at the surface of the concrete and also of the transition in deterioration from the surface to the inner bulk concrete was performed using scanning electron microscopy (SEM) of the as-received concrete surfaces and internal fracture surfaces. Typical SEM micrographs of the as-received surface of the deteriorated concrete are shown in Figure 17. The surface was highly populated by various biological species that were present primarily on the paste and limestone coarse aggregates. The biota appeared to consist of some type of bio-film along with diatom-like structures.

Figure 17. SEM micrographs of as-received deteriorated concrete surface showing biological growth present.

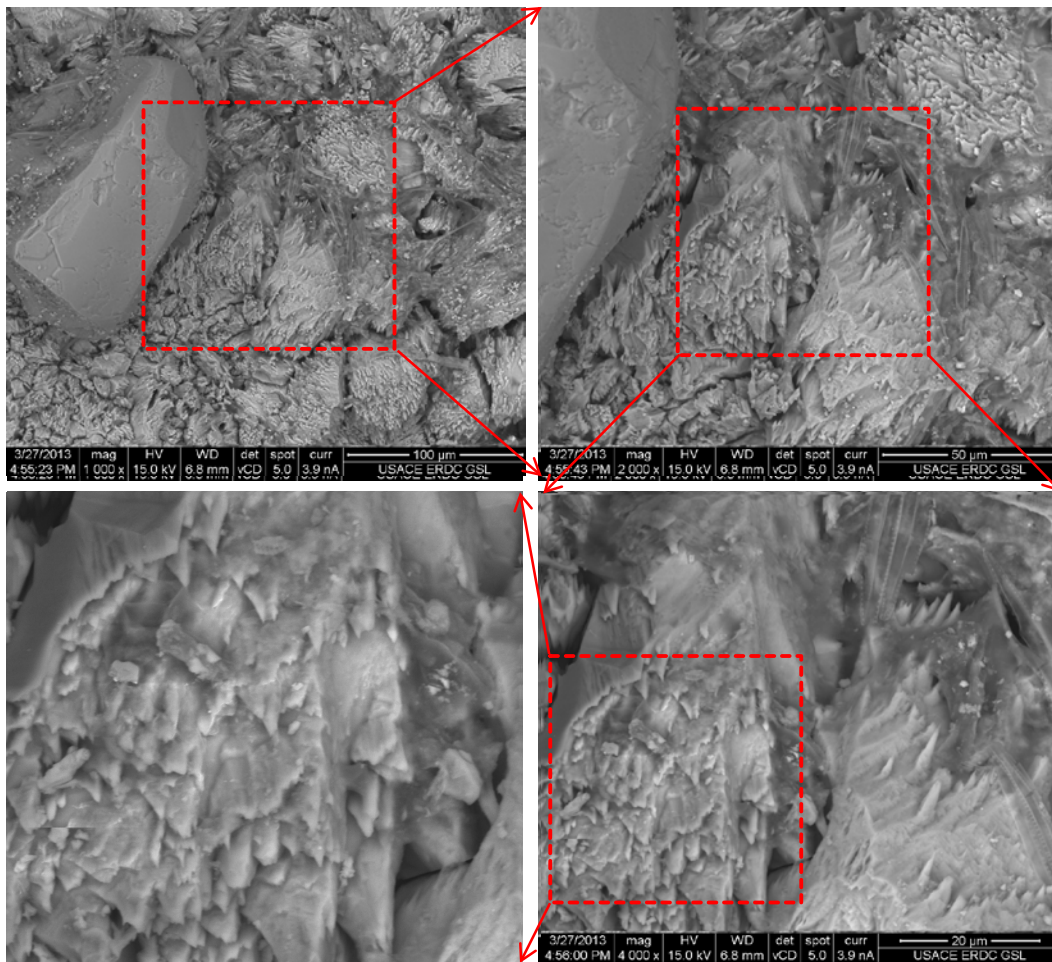
Further investigation of the surface showed a clear distinction between deterioration of limestone coarse aggregates and siliceous fine aggregates. Figure 18 shows an example of deterioration observed on the as-received concrete surface, with biological growth focused on paste and limestone aggregates; an unaffected fine aggregate; and apparent dissolution of an exposed portion of a limestone coarse aggregate. The dissolution of the limestone appeared to be correlated with the rhombohedral structure of calcite and changed with grain orientation in the coarse aggregate.

Figure 18. Progression in damage observed on as-received deteriorated concrete surface showing biological growth, unaffected siliceous fine aggregate, and dissolution of limestone coarse aggregate. Red boxes identify “zoomed in” areas in subsequent images.

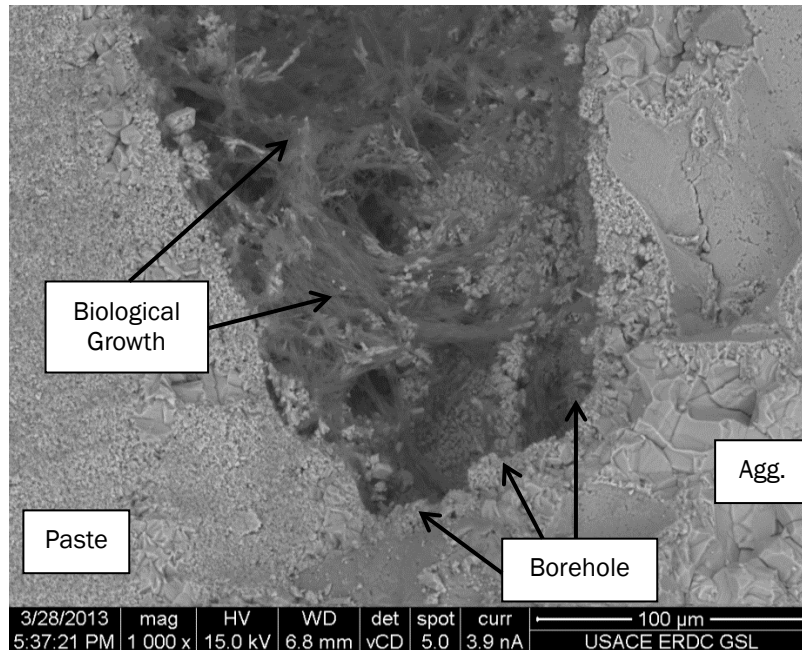
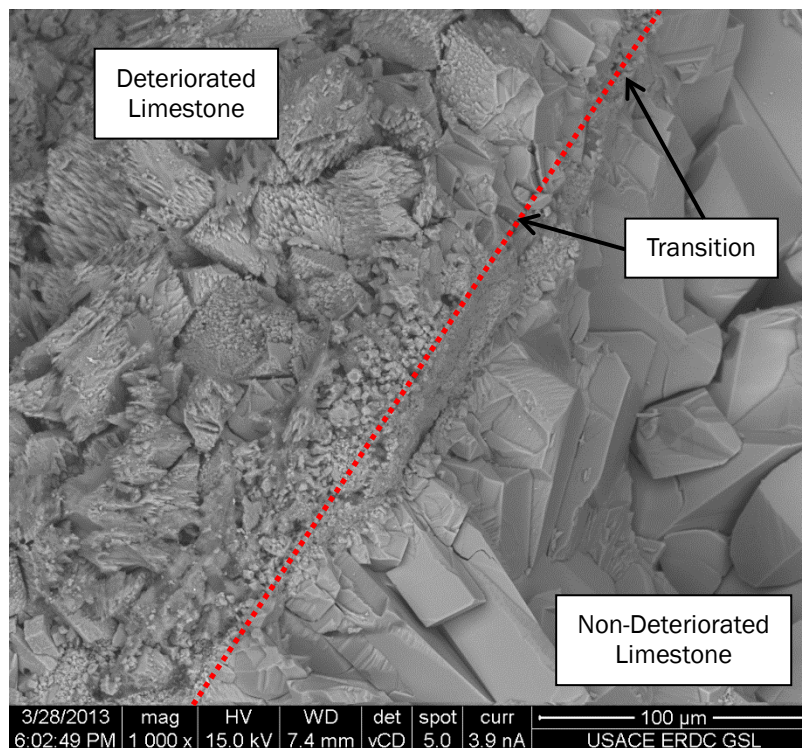
Further examination of microcores extracted from the surface and split longitudinally was used to investigate damage from the surface in. Figure 19 shows examples of deterioration observed on the fracture surface and the transition between the surface deterioration and the non-deteriorated bulk concrete and unaffected aggregates. The inner bulk concrete appeared typical with no detectable other modes of deterioration (see Figure 20).

Figure 19. SEM micrographs of deterioration observed on fracture surface including borehole near exposed surface and transition between deteriorated and non-deteriorated limestone in Pleistocene limestone coarse aggregate.

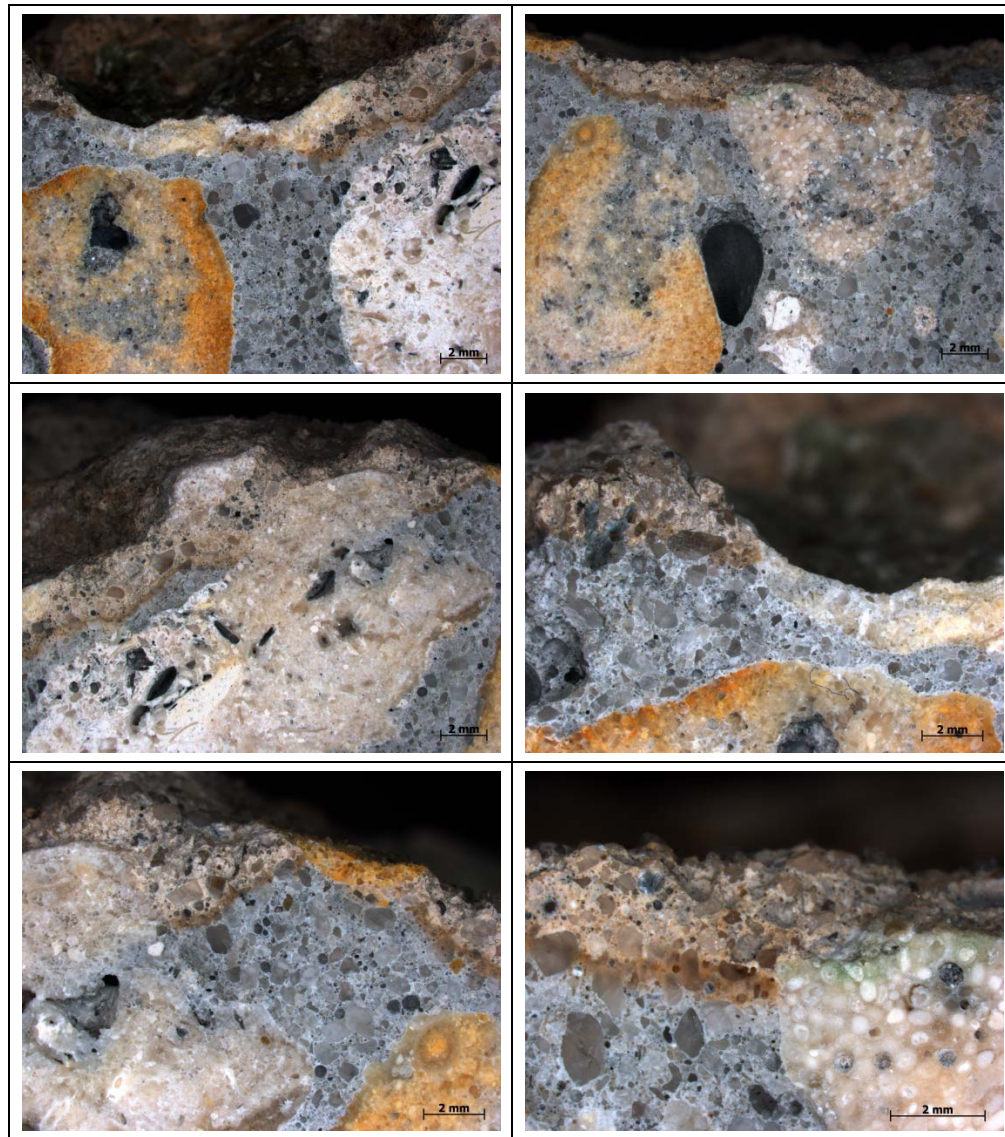
Figure A2. Supplemental photomicrographs of deteriorated concrete from core D2.

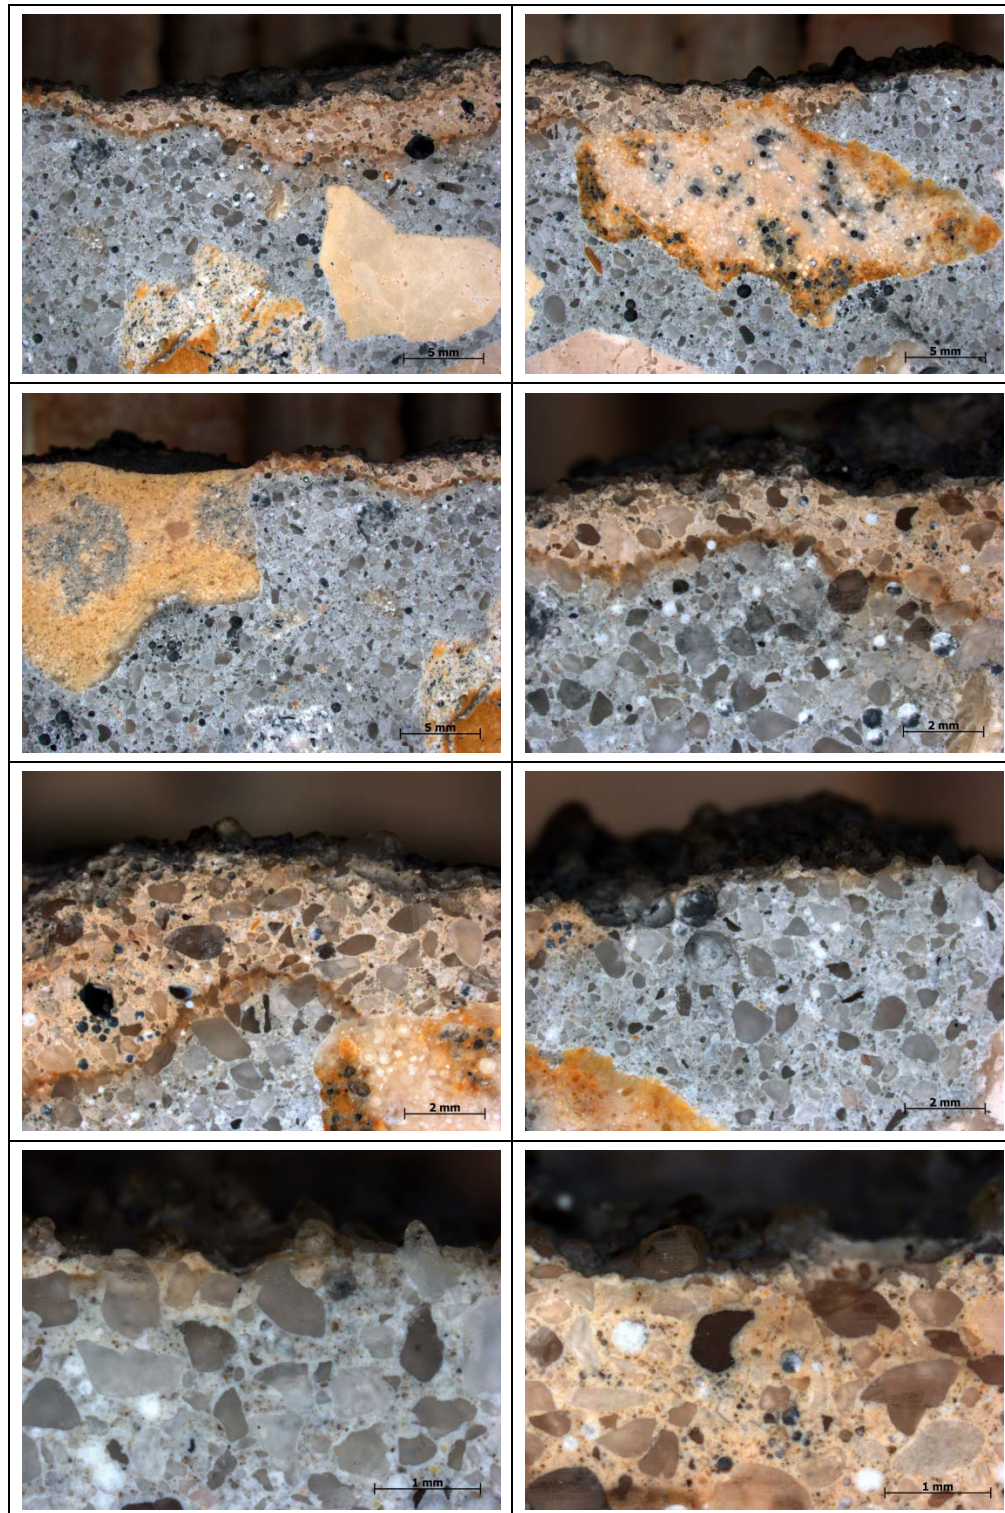
Figure A3. Supplemental photomicrographs of deteriorated concrete from core D3.

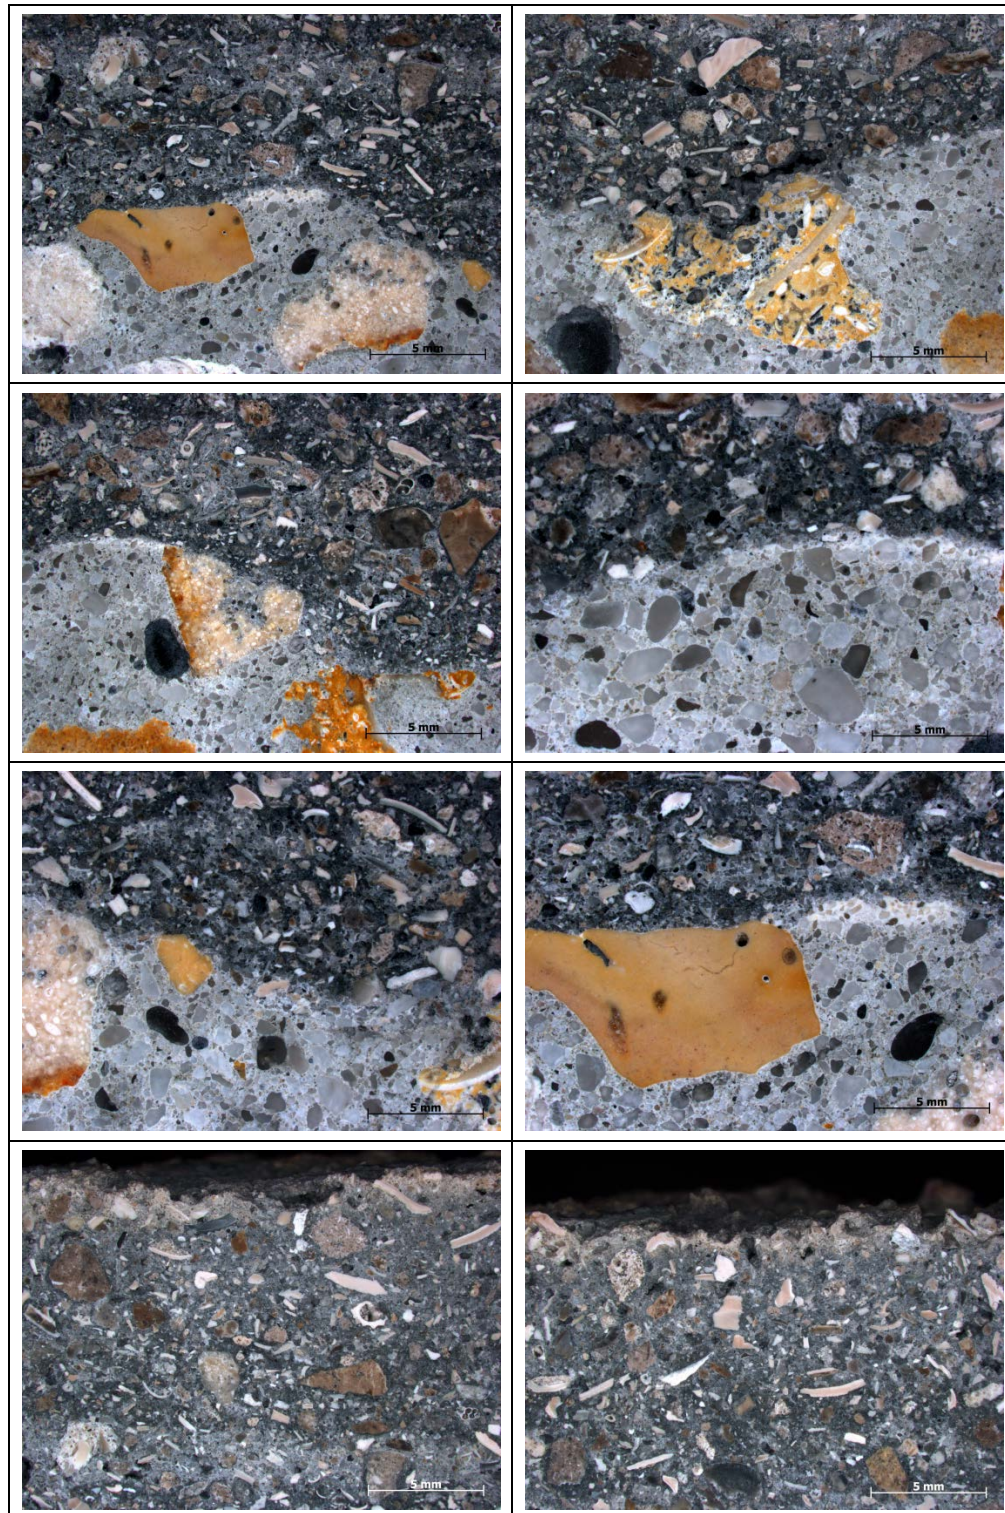
Figure A5. Supplemental photomicrographs of repaired concrete surface.
